# Manhole Inspection Summary

Manhole # S21II\_059MH

Insp Date: **6/21/07 2:35 PM**

**Location** Address: **1800 PRESBURY ST**

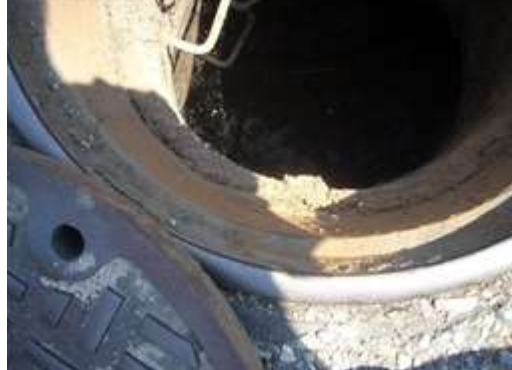
Defect 2

**Frame** Offset: **1** (in.) Condition: ☒ Sound ☐ Cracked ☐ Leaks

FRAME OFFSET

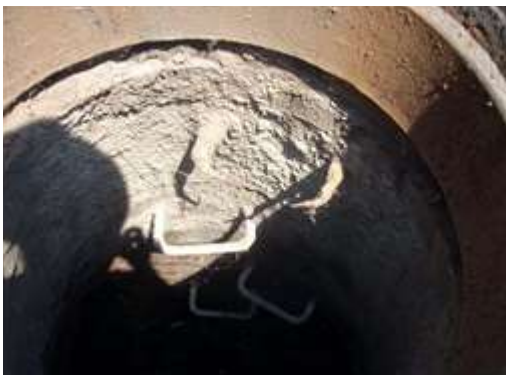
Defect 1

**Steps** Count: **3** Missing: **1** ☐ Corroded

MISSING STEP

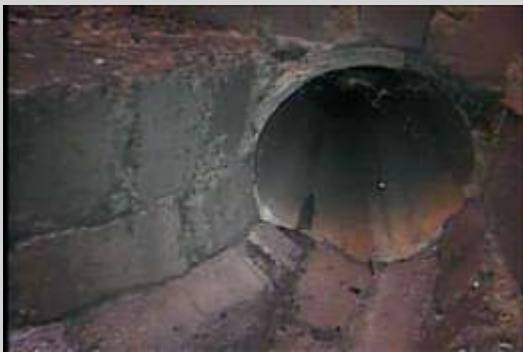
12 O'Clock Outflow

8 in. Circular Gravity Sewer  
Pipe Out @ 12 O'Clock

Pipe Height: **8.4** (in.) Rod and Bar (Angled)  
Pipe Material: **Clay** ☐ Pipe Lined  
Invert Depth: **9.15** (ft.) Flow Characteristics: **Slow**  
Deposits: ☒ None ☐ Mud ☐ Sludge ☐ Debris ☐ Grease  
Silt Depth: (in.) Deposits Extent:  
Infiltration: **None** Pipe Seal Cond: **Sound**

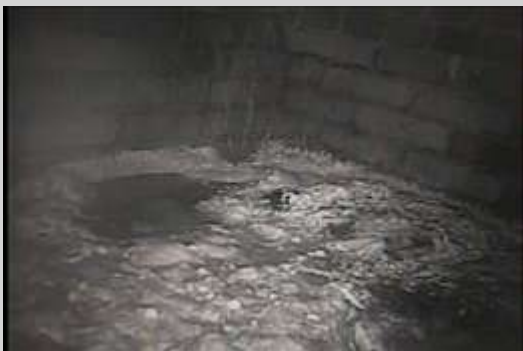
8 O'Clock Inflow

8 in. Circular Gravity Sewer  
Pipe In @ 8 O'Clock

Pipe Height: **7.2** (in.) Rod and Bar (Angled)  
Pipe Material: **Clay** ☐ Pipe Lined  
Invert Depth: **8.92** (ft.) Flow Characteristics: **Slow**  
Deposits: ☐ None ☐ Mud ☐ Sludge ☒ Debris ☒ Grease  
Silt Depth: **8** (in.) Deposits Extent: **Heavy**  
Infiltration: **None** Pipe Seal Cond: **Sound**
